July-Aug., 1971 • Volume 14/No. 7-8

CTC 46, 54 High-Voltage Protective Circuit

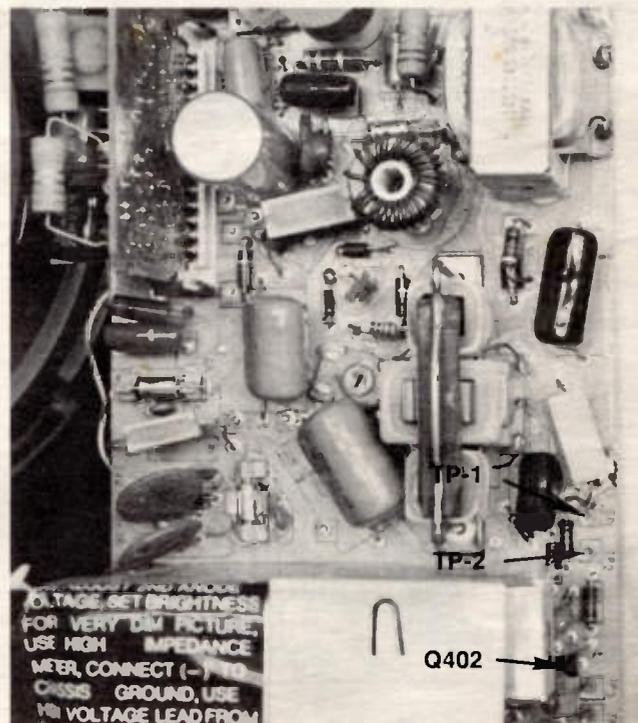
Figure 1—Hold-down Circuit Location (PW 400 Board)

Late production CTC 46 and all CTC 54 chassis include a special hold-down circuit to indicate a failure condition which results in excessive high voltage by producing a non-viewable picture. The hold-down circuit incorporated in these chassis detects an increase in high voltage and renders the picture non-viewable by throwing the horizontal oscillator far enough out of sync that adjustment of the customer **Horizontal-Hold control** or **Hold-Limit** service adjustment will not restore a normal picture. In the event horizontal sync is lost, the problem in these chassis could be either horizontal sync/oscillator related, or the normal operation of the hold-down circuit signaling a condition of excessive high voltage. A malfunction of the hold-down circuit will also produce a non-viewable picture. It is extremely important that correct high-voltage and proper hold-down circuit operation are confirmed as a step in servicing these chassis.

CTC 46 and CTC 54 chassis using this protective hold-down circuit can be easily identified by the additional transistor (Q402), test-points (TP-1 and TP-2), and associated components located adjacent to the horizontal oscillator (MAH Module) area of the PW 400 circuit board—see Figure-1.

1. Ground TP-2 with set operating and adjust **Horizontal-Hold** to sync picture. If horizontal sync can be restored, problem is due to excessive high voltage and must be corrected before instrument back cover is replaced. If picture cannot be "synced," problem is probably in the horizontal oscillator/sync circuit.

2. **Important:** Before replacing instrument back-cover, check operation of hold-down circuit as follows: With instrument operating on 120 VAC line and all controls set for a normal picture, temporarily short TP-1 to TP-2. This **MUST** cause picture to lose horizontal sync. Adjusting **Brightness** control should cause a small shift in the number of bars visible on the screen.

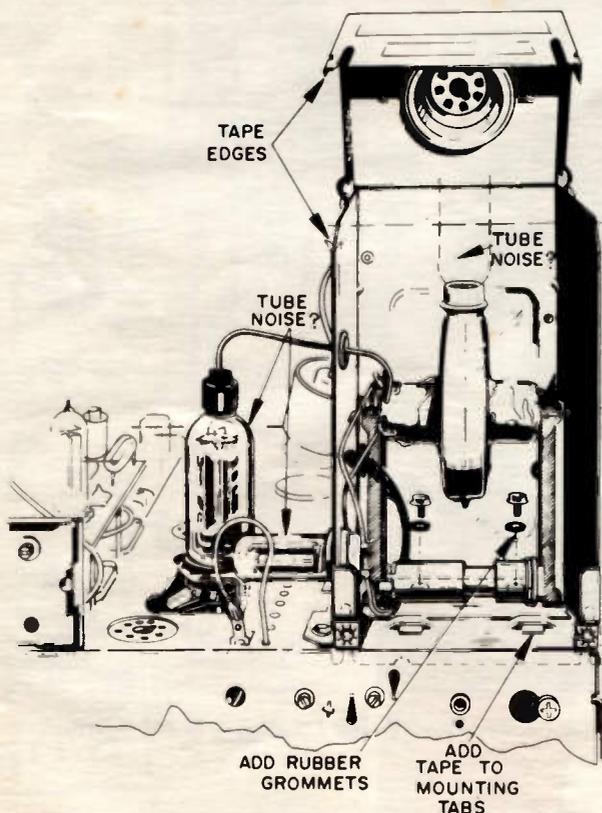
Figure 2—Noise Suppression Techniques

Television receivers produce acoustical energy (noise) at the horizontal sweep frequency. Although the frequency of this sound is at the upper limit of hearing, sometimes a set owner, whose hearing is acute, objects to this 15.7 kHz noise. When complaints of this nature are encountered, several steps can be taken to minimize the noise.

One cause of this noise is the vibration of the glass envelopes of horizontal circuit tubes. So first try substituting the horizontal output, damper, regulator (if used) and high-voltage rectifier tubes, one at a time, to see if the noise is reduced. Or, as an alternative, hold an insulated rod against the glass envelope of each tube to see if it will damp-out the glass vibration. Replace the tube or tubes that are causing the noise.

If the chassis has a pincushion correction circuit, slightly reduce the setting of the **Pincushion Amplitude** control and listen for a reduction in noise level. If this check reduces the sound level, tighten the pincushion transformer mounting and/or insert tapered toothpicks between the coils and the transformer core.

Use an insulated rod to press on the mounting screws, rivets, brackets and hinges of the high-voltage compartment cover. Any vibrating part that produces noise can be silenced by applying a dab of silicone rubber, or by adding a small piece of electrical tape. If the high-voltage compartment cover is the source of noise, add a cork pad or tape to the contact edges of the cover.

To eliminate the horizontal output transformer singing noise, carefully loosen the transformer from its mounting, just far enough to insert rubber spacers between the transformer and its mount. Also, add rubber grommets to the transformer mounting screws. Carefully reinsert transformer mounting screws into the chassis—the transformer should be tightened sufficiently to insure a secure mounting; but not so tight as to defeat the purpose of the rubber inserts or to strip the self-tapping screws. Turn the receiver "on" and check for normal operation.

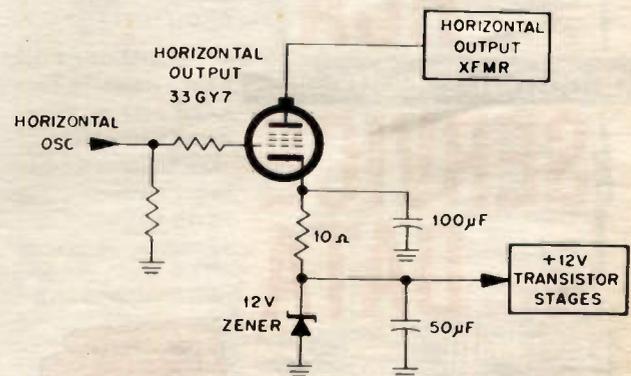
Figure 4—Regulated Transistor Supply

The simplified circuit (Figure-4) illustrates a zener regulator system used in the KCS 176 black and white television chassis. The DC voltage supplied from the cathode of the horizontal output tube is held constant by the 12-volt zener; thus, supplying regulated 12 volts required for transistor circuitry. Failure of this zener would cause a loss in the constant 12-volt supply to the transistor stages and also cathode bias of the horizontal output stage.

As previously discussed, several things must be considered in the design of zener circuitry—voltage, current, and wattage. Due to the critical nature of these circuits it is recommended that only **exact** replacements (**RCA Stock Numbers from RCA Service Data**) be used when a failure is noted.

When replacing a defective zener diode certain precautions should be taken, just as when replacing other solid state devices (transistors, integrated circuits, etc.). Care must be taken to prevent possible damage to the zener due to excessive **heat** or **voltage**; soldering irons should be of **low wattage** and **grounded** in such a way that will prevent possible damage to the zener during the soldering operation.
