RADIO RETAILING'S TRICKS OF THE TRADE

Revised and Enlarged - Third Edition

**Practical "bread and butter" tips for radio dealers and
service men on how to find and repair the most common
troubles peculiar to specific models of receivers**

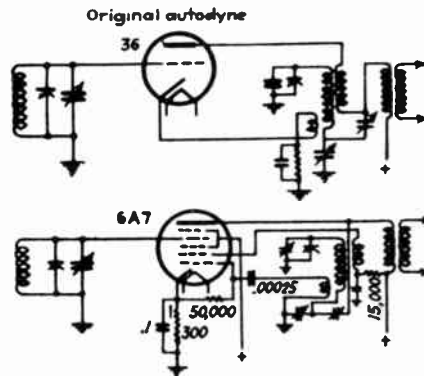
PHILCO 14 (Early). 36 autodyne first detector does not oscillate stably at lower frequencies, changing of oscillator coils and bias resistor does not affect permanent cure. Nor does replacement of tube, mica in tuning gang trimmers or

cloth covered wiring . . . Substitute 6A7 for 36, employing new circuit diagrammed. The same oscillator coil is used, but the various windings employed differently. Slight retrimming of all condensers associated with circuit is all that is necessary when revamping has been done.

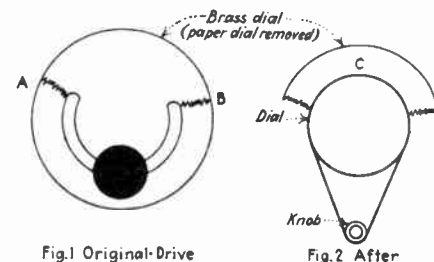
Fig. 1 Original-Drive

SPARTON AC7, 62, 63. Replacing worn-out friction dial drives . . . Remove chassis from set. Remove spring tension arrangement from shaft and replace with brass rod or old variable condenser spacer tube, drilled to fit snugly over shaft. File brass rod down until it is spool shaped, similar to spools used on sewing machines. This may be done by putting the rod of spacer tube on a small bolt, rotating the bolt in an electric drill and holding a file against it. The spool should now be covered with tape and metallic-xed (a cement) in place. It should then be soldered to the knob shaft, easily removed by lifting the spring before the tape is ce-
