# ANTIQUE RADIO CLASSIFIED

SEPTEMBER 1992

## Repairing Intermediate Frequency Transformers

*Daniel Schoo presents valuable information for the repair of tube-type superheterodyne radios. He explains the construction of IF transformers made in the 1950s and 1960s and follows a step-by-step procedure for making repairs to them. The procedures are generic enough to make repair of almost any IF transformer possible. (Editor)*

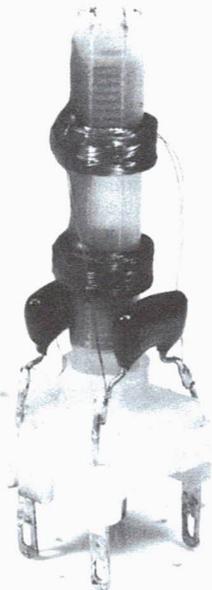
Figure 9. Zenith transformer after rebuilding.

slot so they do not short to the shell. Push the capacitors back far enough to clear the shell when it is slid back on. Figure 9 shows a Zenith transformer after rebuilding.

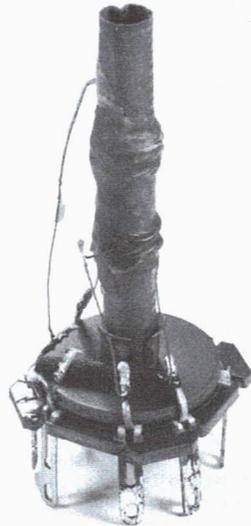
Figure 10. Zenith large footprint FM discriminator transformer with the cover removed and the wires removed from the pins.

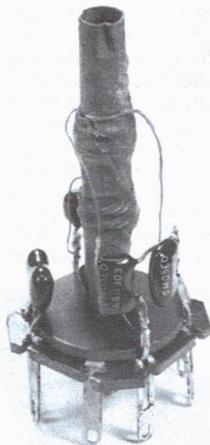
Figure 13. Zenith discriminator transformer reassembled with the capacitors installed.

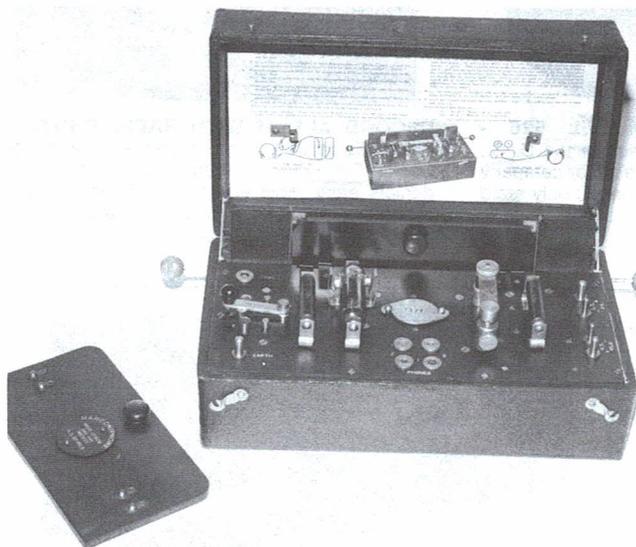
Figure 1. Marconiphone RB10 receiver with lid open and spare range block.

per spades across the surface of the block in exactly the same manner as for the V2. The effect of the spade is to reduce the inductance of the coil in proportion to the area of the coil covered by the spade. Like the V2 receiver, the spades are attached to graduated rods which are used as a guide to tuning, together with a calibration chart supplied with each range block.

Each range block contains two pancake-type coils. The set is tuned by moving a pair of flat cop-

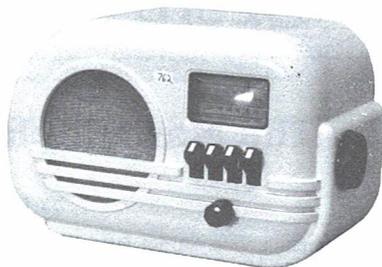
**BELMONT MODEL 151** - This is a typical Belmont design with the tuning knob on the right side and the push buttons across the front. It is a 5-tube, AC/DC chassis. These radios always have an unusual, eye-catching appearance. It is a 5-tube, AC/DC chassis. (Walter V. Worth - Wollaston, MA)

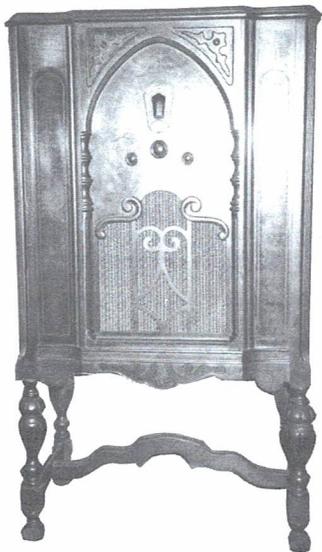
## SILVER MARSHALL CHASSIS #30 -

Only the grille cloth is not original in this circa 1930 floor model. The radio uses the following tube types: (4) #24s (3 RFs, 1 detector); (1) #27 (1st audio); (2) #45s (push-pull output); and (1) #80 (rectifier). Like many sets of this era, it has phono connections. The schematic is in Riders, Volume 1. (*G. Hausske - Wheaton, IL*)

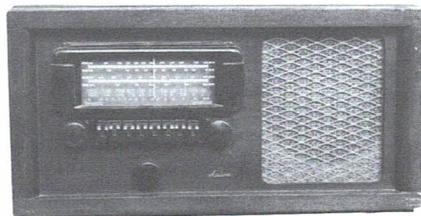
**WARD AIRLINE MODEL 64BR1808A** - Made in 1947, this big table set is a great performer. It has 4 shortwave spread bands and uses 8 tubes. Two of them are 6K6s in push-pull. (*Doug Burskey - Mansfield, OH*)

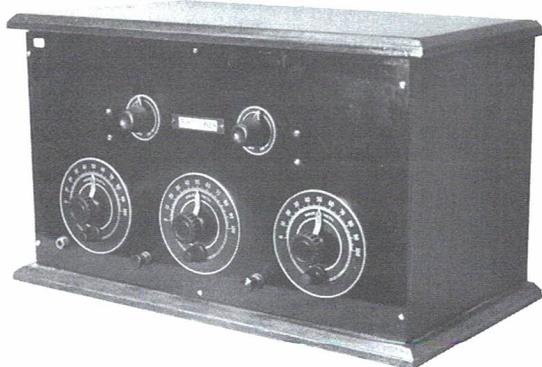
**JOSEPH W. JONES** - This 5-tube battery set may be a Model J125 of 1925 vintage. The coarse dial pointers are helped by the separate vernier knobs underneath. These sets are nicely designed and put together. The case, a reproduction I made, has room for all batteries inside. (*Walter V. Worth - Wollaston, MA*)

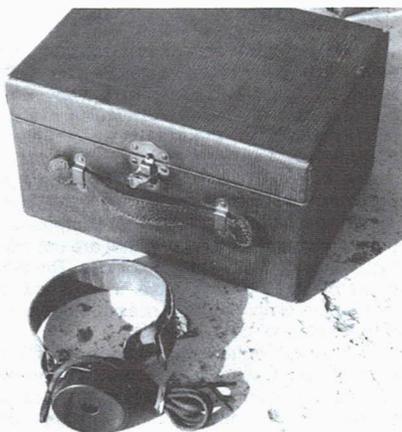
Figure 1. The AC Companion in its leatherette box and single leather band headphone.

While rummaging through an antique co-op one day, I came across the black, leatherette-covered box shown in Figure 1. It was approximately 11" long, 8" deep and 6" high. My first thought was that it was some kind of test equipment or "quack" medical device. Upon opening the lid, I was still not sure what it was. Two shoulder-type, clear glass tubes stuck out of a polished panel with one large center dial. A smaller knob marked "sensitivity," a toggle switch and some binding posts, shown in Figure 2, were additional features. The lettering on the main dial was faded and hard to read: "ICS" (?), "AC" (?), "COMPAN...NY (?)."

The AC Companion has a compartment alongside the panel for headphones and storage of the AC cord. The whole interior of the set is lined in a blue-purple, velvet-like material. The velvet material in the cover lid is stamped "Companion." The panel is a high gloss Bakelite with
