# RAPID TV REPAIR

G. WARREN HEATH

GERNSBACK LIBRARY

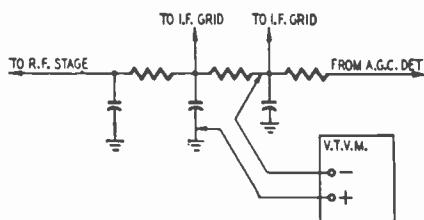
Fig. 2-A. *Measuring the agc voltage.*

The normal voltage at the grids of the rf amplifier and some video if tubes should range from zero to approximately  $-10$  volts. You can measure the agc voltage as shown in Fig. 2-A. If the bias

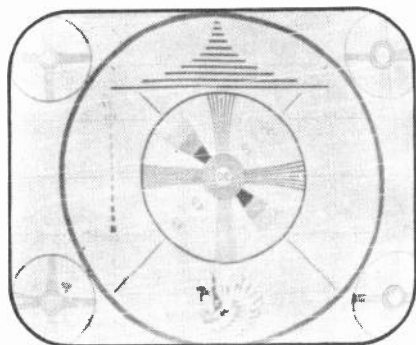
Fig. 3-A. *Effect of defective agc on the test pattern.*

on the controlled tube is excessively negative, the pix may become very faint or will be lost entirely, including the sound. On blank channels, noise spots will not appear. A defect in agc can cause no pix (sound and raster ok); no pix or sound (raster ok); pix dark with buzz, pix pulling or bending, tearing, weak and snowy pix with weak sound, and weak pix; or no horizontal and vertical sync, or hum. See Fig. 3-A.

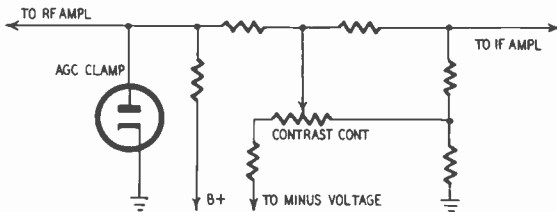
Fig. 5-A. Simple agc clamp circuit.

Changes in resistors (see Fig. 5-A) can produce any symptoms in between the above cases. A short on the resistor connected to B+ can damage rf and agc controlled tubes by application of positive voltage to their grids as well as possible destruction of the agc clamp tube. (Refer also to section on keyed agc.)

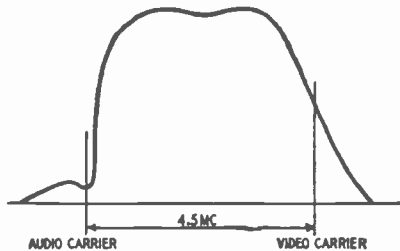
Fig. 6-A. Position of the video carrier on the slope of the if response curve.

Failure of sound and picture to track (that is, best sound and picture do not occur together) indicates need for realignment of front end or if. Note that the foregoing does *not* mean the brightest picture, as the picture carrier is placed *halfway* up the pix carrier slope on the if curve. See Fig. 6-A.

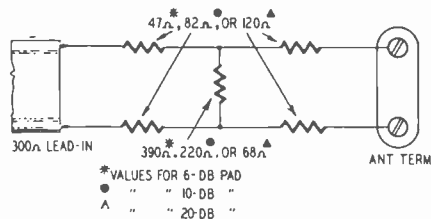
Fig. 7-A. Overloading, due to excessive signal, can be cured by using attenuator pad.

The higher the antenna, the greater the area covered. Always check direction other antennas face. Antenna should clear all trees and buildings, and should not be placed near elevators, metal surfaces or electrical devices. A very strong signal can cause the pix to smear or bounce, due to overloading of rf amplifier tube. Agc may be defective or inadequate. A simple remedy is to insert an attenuator between the transmission line and antenna terminals. See Fig. 7-A. Use 1/2 watt, carbon resistors.

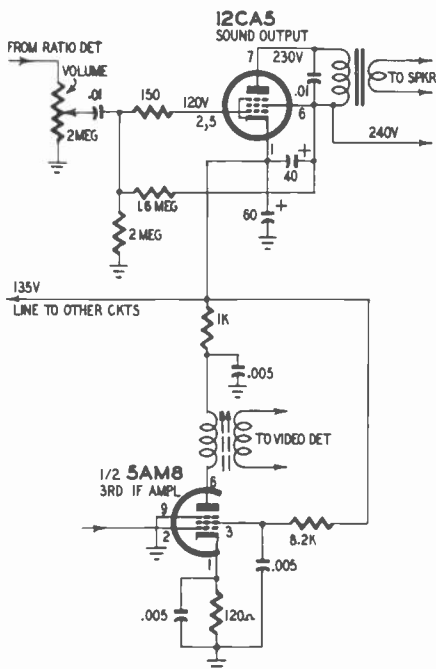
Fig. 8-A. The audio-output tube is sometimes used as a voltage divider.

When servicing the low-voltage power supply, consider the increasing tendency of set manufacturers to eliminate dropping resistors as voltage dividers to provide different plate voltages. In some sets voltage division is accomplished by using the audio-output tube (see Fig. 8-A.) as a dropping resistor in series with several other stages, especially the video if tubes.

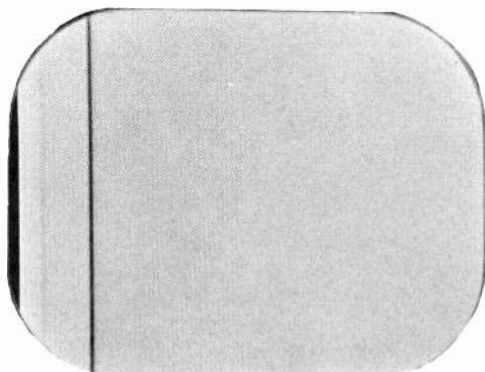
Fig. 1-B. *Appearance of Barkhausen oscillation on screen.*

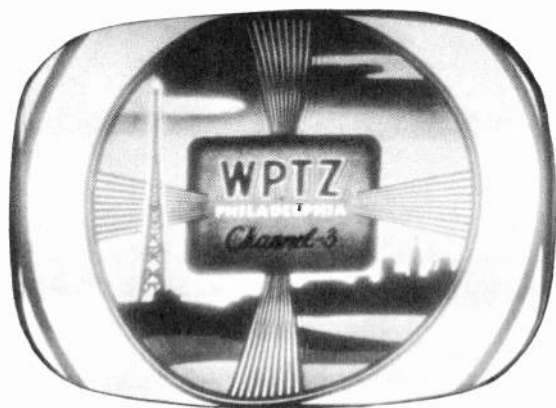
Fig. 2-B. Vertical wedges show severe bending.

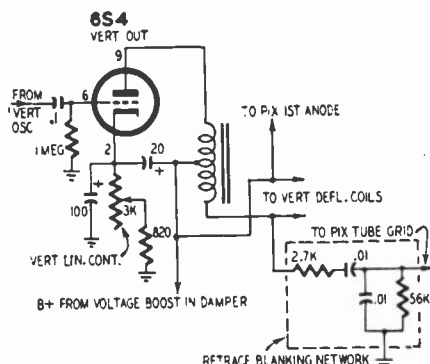
Fig. 3-B. This vertical-output circuit gets its plate voltage from the B+ boost in the damper.

When trouble develops in a vertical circuit operating from the B+ boost line, check the electrolytic decoupling capacitor at the B+ feed line. The boost voltage may be increased by connecting the vertical sweep to another B+ source.

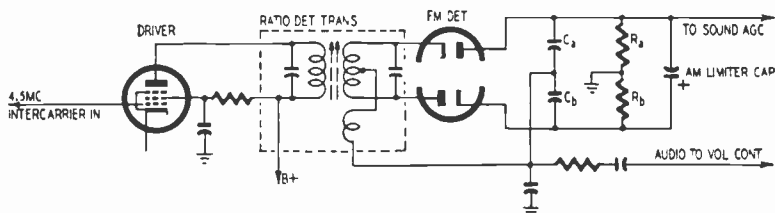
Fig. 5-B. *Typical ratio-detector circuit.*

accompanied by pix distortion), but disappearing with a weak signal. Occasionally buzz will be heard only with a weak signal produced by unbalance in the ratio detector and caused by defective ratio-detector capacitors ( $C_a$  and  $C_b$  in Fig. 5-B), or resistors ( $R_a$  and  $R_b$  in Fig. 5-B).

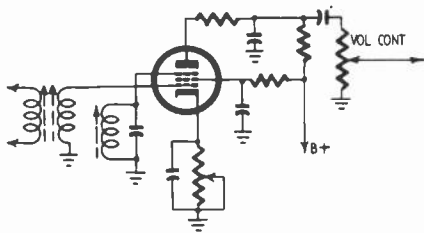
Fig. 6-B. Gated beam FM detector circuit.

**SYMPTOMS:** The gated-beam FM detector circuit (Fig. 6-B) becoming increasingly employed by set manufacturers, incorporates a 6BN6 tube serving as a limiter-detector in the audio circuit.

**SERVICE:** A variable cathode resistor, termed the buzz control regulates intercarrier buzz. The circuit may be aligned using the regular TV signal. Connect a low ohm resistor across the antenna terminals to reduce signal strength. When a hissing is noted, adjust slugs in sound take-off transformer between sound amplifier and 6BN6, and quadrature coil, in conjunction with buzz control to produce sharpest sound with minimum of buzz. Hiss should be heard during adjustments; if it disappears, further reduce input signal.

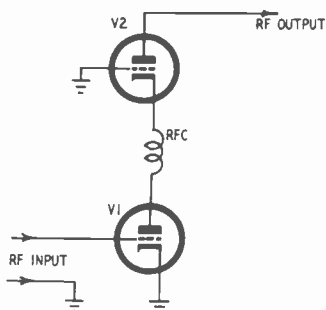
*Fig. 1-C. Simplified circuit of the cascode tuner. The two tubes are connected in series across the B+ line. Because the cathode of V2 is about 125 volts above ground, there can be a breakdown between the filament and cathode.*

While the cathode of V1 (Fig. 1-C) is at ground potential, the cathode of V2 is about 125 volts above ground. Thus, while a heater-cathode leakage is of little consequence in V1, it can cause a great deal of trouble in V2. Because of the large potential difference between heater and cathode of V2 these elements frequently short.

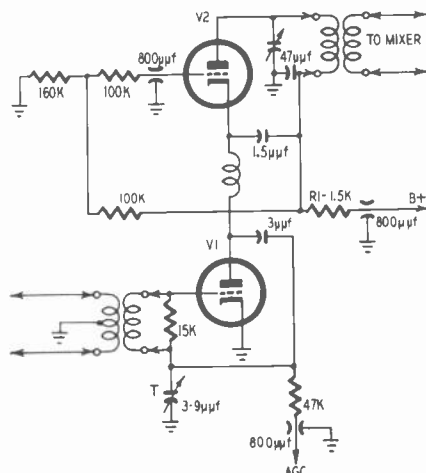
Fig. 2-C. *Circuit of the cascode tuner.*

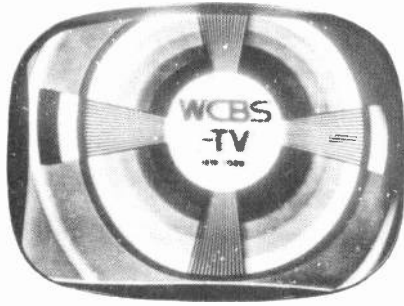
*Fig. 3-C. Pix is improperly centered due to intermittent horizontal shift.*

**SYMPTOMS:** Intermittent, horizontal shift of pix. See Fig. 3-C.

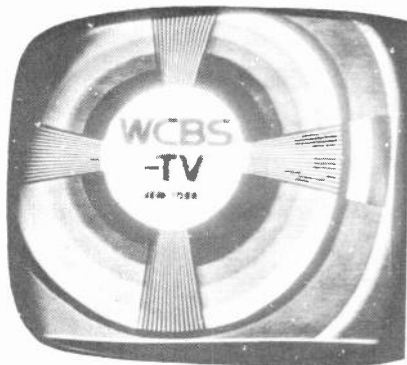
Fig. 4-C. *Shifting of pix by misadjusted focus assembly.*

**SYMPTOMS:** Picture has shifted. Dark, crescent-shaped area around the left side and bottom of the picture. See Fig. 4-C.

**SERVICE:** Accidental shifting of deflection yoke and focus unit (when installing new picture tube) produces this effect. The yoke and focus unit are usually mounted in brackets which permit the units to be shifted slightly in all directions. Moving the deflection yoke toward the rear or shifting the focus unit to one side or rotating it about either axis will produce this trouble.

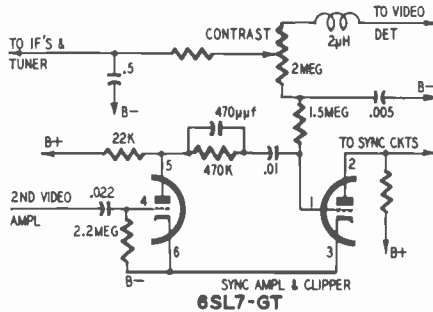
Fig. 5-C. Contrast-control circuit.

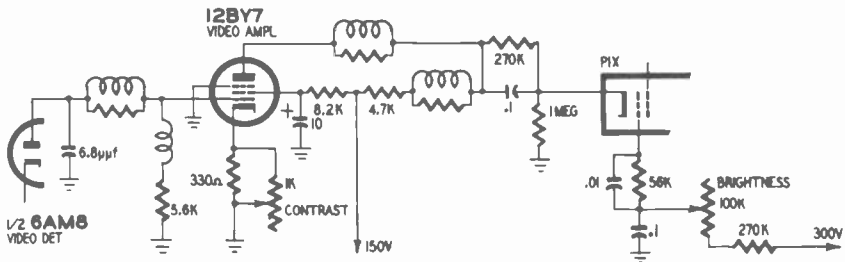
Fig. 7-C. Contrast control in the cathode circuit of the video amplifier. Compare with that shown in Fig. 5-C.

The contrast control may be either in the video if section or the video amplifier. In sets of early vintage, without agc, the contrast control had to be varied to adjust the amount of signal at the video detector; in sets with agc, the contrast control is in the video amplifier section. See Fig. 7-C.

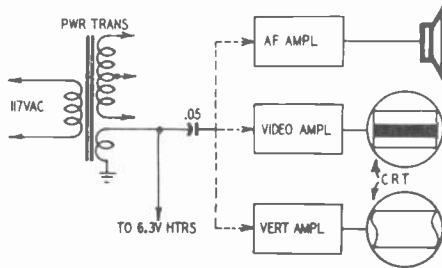
Fig. 8-C. Filament voltage can be used as a signal source.

The intensity of the bars should become greater as the generator lead is moved back from stage to stage. Any circuit causing a reduction in signal strength is the defective stage. If you do not have a portable signal generator, use the receiver filament voltage (do not use rectifier filament) as a signal source, as shown in Fig. 8-C. Click testing may be helpful.

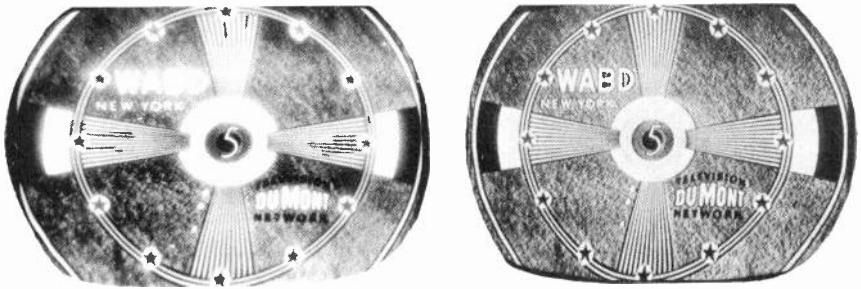
*Fig. 9-C. A photo of the face of the picture tube (before cleaning) is shown at the left. The photo at the right shows the same test pattern after the screen and the mask were cleaned. The high voltage of the picture tube seems to attract dust and will deposit a uniform layer of it over the screen.*

**SERVICE:** The high electrostatic charge on the face of the pix tube attracts dust. This forms a fine uniform film of dirt across the screen, even though it is covered by a mask. Fig. 9-C shows pictures taken before and after cleaning the tube. Pull plug from line and make sure that there is no voltage or charge on tube. Clean face carefully with soft cloth and lukewarm water. Do not use soaps, abrasives or cleansers. Clean mask at the same time.

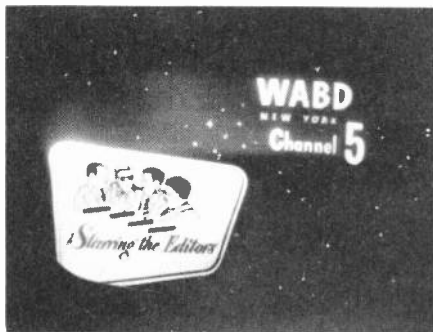
*Fig. 1-D. Poor dc restoration results in a gray picture. Dc restorers are found in old receivers, many of which are still in use.*

Restorer failure causes darker pix, requires higher than normal setting of brightness control, and vertical-retrace lines to appear. Pix may become washed out. Sync lock may be affected, with critical horizontal and vertical-hold controls, especially the latter. A cathode-filament short in the dc restorer tube can cause pix distortion and a 60-cycle hum bar on the screen. It may also cause raster bending due to hum passage on through sync circuitry, if the sync is taken off the dc restorer, a common practice in earlier sets.

Dc restoration is not necessary with direct video coupling, and you should not get symptoms of poor dc restoration unless your video-output amplifier tube is giving trouble. It is also possible that the voltage relationships between the grid and cathode of the picture tube have been upset by aging resistors or poor low-voltage power-supply regulation.

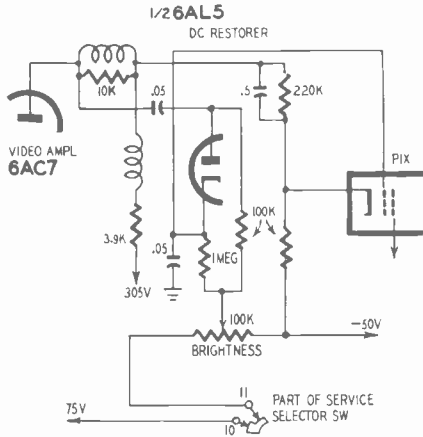
Fig. 2-D. The dc restorer acts as an automatic brightness control.

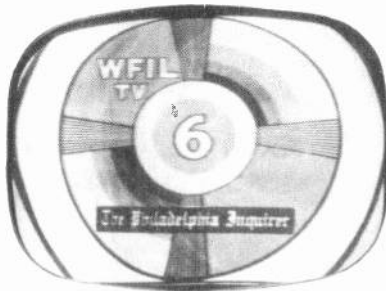
Fig. 3-D. Poor pix detail because of loss of higher video frequencies.

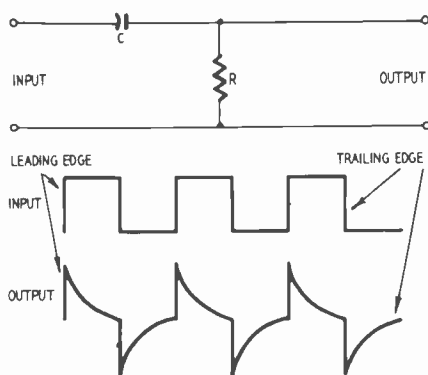
Fig. 4-D. *Effect of differentiator on horizontal-sync pulses.*

**SERVICE:** Differentiator is an R-C network (high-pass filter) used to separate horizontal pulses for triggering the horizontal

oscillator. See Fig. 4-D. From sync separator, the output is usually fed to afc circuit of horizontal-sweep system. Check for defective capacitors or resistors in differentiator circuit. Test these small-valued capacitors by substitution, and not by shunting.

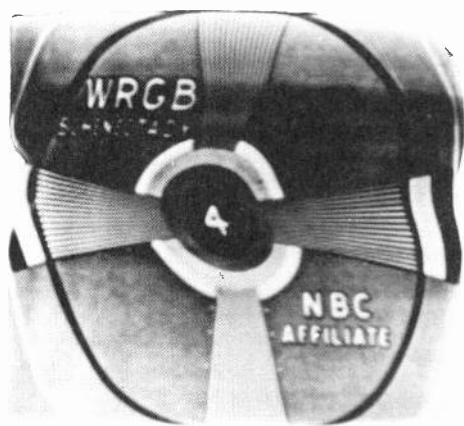
Fig 5-D. *Distortion due to hum voltage*

is caused by hum in any stage that is used to amplify the pix signal. In the latter instance, the trouble may be due to heater-cathode leakage in any tube from the tuner to the input of the CRT. If a scope is available, check the video amplifier. For stages prior to the video detector, use a detector-type probe in series with hot lead of scope.

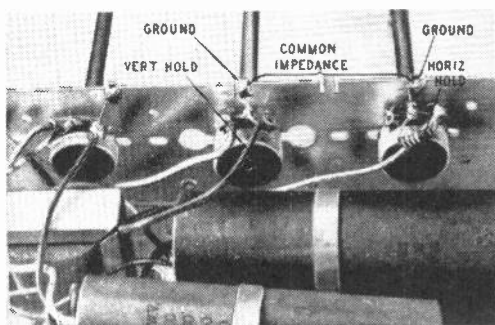
Fig. 6-D. Photo shows close positioning of vertical- and horizontal-hold controls.

Fig. 6-D). The chassis ground currents from these controls will thus mix.

The chassis has relatively low resistance and reactance, hence a low impedance to currents of these frequencies. But the large flyback pulse of the vertical oscillator can feed directly into the horizontal-oscillator circuit and distort the first few lines of the picture. Additional afc control line filtering will not help much in this situation; neither will more complete filtering of the B-plus

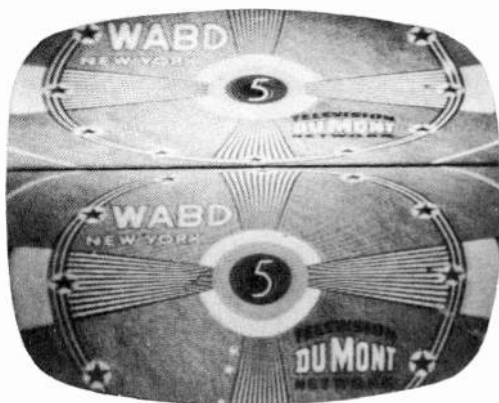
*Fig. 7-D. Double pix caused by vertical oscillator working at 30 cps.*

**SERVICE:** Caused by vertical oscillator working at 30 cycles per second instead of 60 cycles, due to increase in time constant of vertical-oscillator circuit.

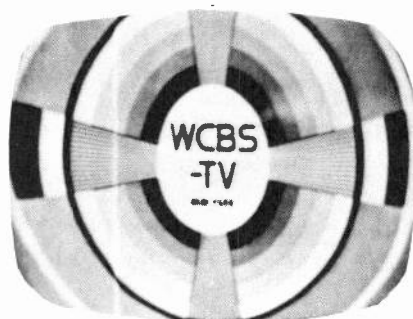
Fig. 8-D. *Overdrive indicated by vertical white line.*

**SYMPTOMS:** Short life of horizontal-output tube. High-voltage fuse may blow. Overdrive lines appear on screen. Pix may stretch

on left-hand side, sync is not steady. See Fig. 8-D.

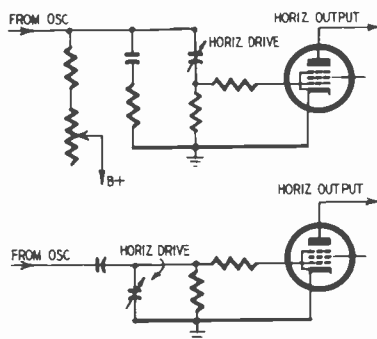
Fig. 9-D. *Typical horizontal-drive control circuits.*

Typical horizontal-drive controls are illustrated in Fig. 9-D.

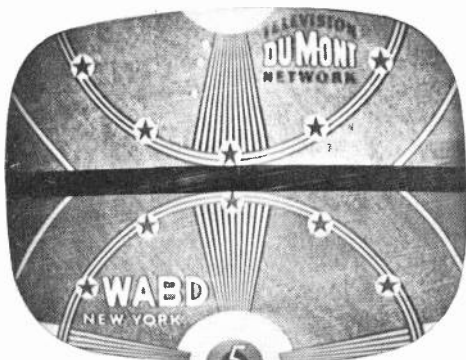
Fig 1-E. *Rolling pix vertically permits examination of blanking bar.*

**SERVICE:** Check adjustment of vertical size, linearity and centering controls when receiving program. Remove vertical-output tube. This will result in a horizontal white line. Adjust centering control until line is in vertical center of screen. Replace vertical-output tube and adjust vertical size and linearity controls for correct pix. Rotate vertical hold to allow pix to roll slowly. See Fig. 1-E. Blanking bar should not change thickness going from top to bottom.

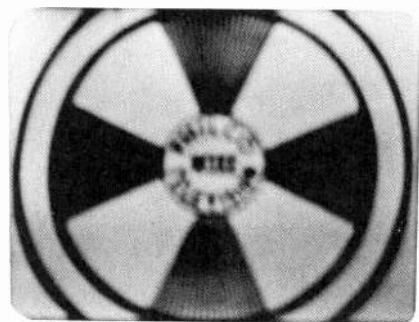
Fig 1-F. *Blurred pix due to poor focus.*

**SYMPTOMS:** Improper focus, resulting in blurred pix. See Fig. 1-F.

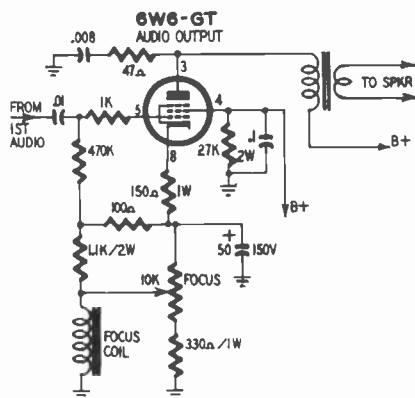
Fig. 2-F. *Focus coil in audio-output circuit.*

The focus coil often forms part of the cathode, screen, or plate circuit of the audio-output tube. See Fig. 2-F. Focus is controlled by a potentiometer placed in the cathode circuit of the same tube. The focus coil is usually bypassed by a large electrolytic capacitor. Any of the usual troubles in the audio stage can cause an out-of-focus condition—leaky coupling capacitors, defective output tube, shorted screen, plate or cathode bypass capacitors, open output transformer primary, and defective audio-amplifier tube. If the speaker should become detached, the focus coil would lose voltage and be inoperative.

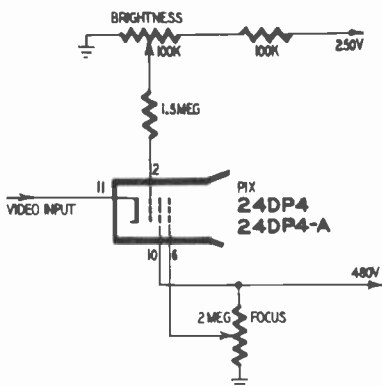
Fig. 3-F. This circuit uses electrostatic focusing.

Erratic focus can be due to a defective focus potentiometer. See Fig. 3-F. Connect a vtvm from center arm of the potentiometer to either end. Rotate the variable arm and watch meter needle. Needle movement should be smooth. If jumpy, replace control.

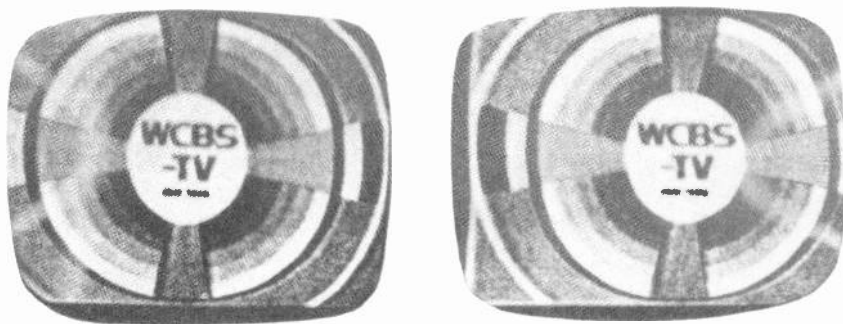
Fig. 4-F. *Foldover can appear at left side of screen (pix at left) or at right side (see pix at the right).*

(this includes damper, HV, and yoke circuits) will lengthen the retrace time. With most high-efficiency transformers the entire pix information is not contained in a single line, but continues for a short period of the otherwise invisible retrace, giving the appearance of a transparent folding-over of the pix on the edge.

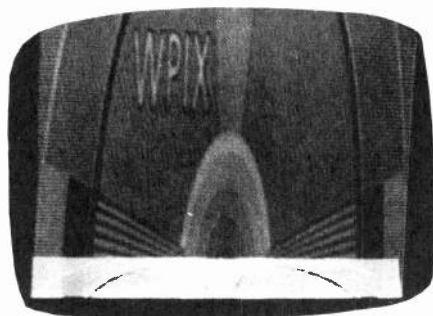
Fig. 6-F. Photo shows vertical foldover.

**SERVICE:** Vertical-linearity control affects upper part of pix, and vertical-size control changes overall size, especially bottom of pix. Misadjusted centering control and linearity control may cause folding at top. Misadjusted vertical-size control may cause folding at bottom.

Foldover at the bottom usually indicates trouble in the cathode circuit of the vertical-output tube. Check the vertical oscillator and output tubes by substitution; also the LV rectifier.

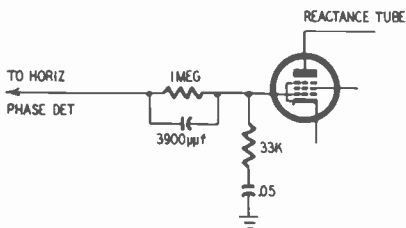
Fig. 1-G. Anti-hunting network is connected between the horizontal-phase detector and the reactance-tube control grid. A defect here produces a gear tooth effect on the screen.

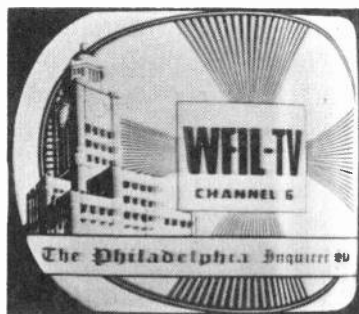
*Fig. 7-H. Photo shows example of horizontal nonlinearity.*

Poor linearity can take the form of an uneven sweep (Fig. 7-H)

or foldover. The linearity coil itself is usually effective only in the case of slight nonlinearity. In such a case, the slug should be varied. If turns are shorted (this lowers the inductance) all adjustments will either be ineffective or critical and unstable.

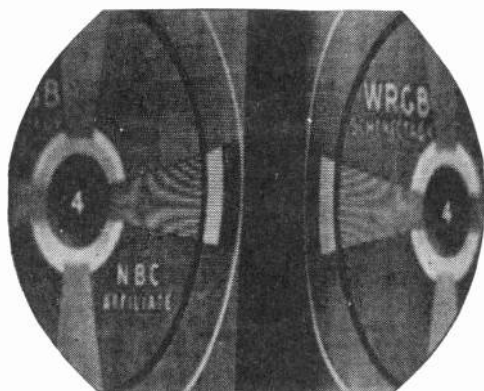
**Fig. 8-H.** Blanking bar is indication of incorrect horizontal phasing.

**SYMPTOMS:** Out-of-phase condition usually evidenced by a split pix, blanking bar in center, right half on left and left half on right.

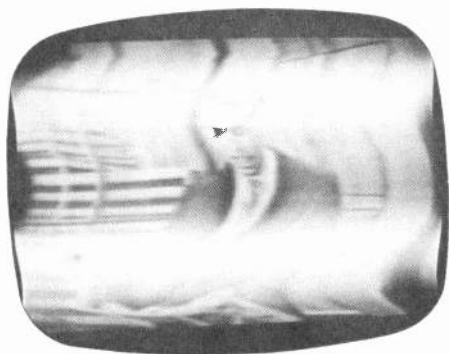
Fig. 10-H. 120-cycle hum in pix.

Hum in horizontal-deflection circuits causes waviness or pulling in pix without bars, due to defective tube. See Fig. 10-H. The waving or buckling of vertical objects as pix changes is often due to defective .01- $\mu$ f capacitor (C5 in Fig. 6-H) in horizontal-phase detector circuit. In some instances, replacing .001- $\mu$ f capacitors in

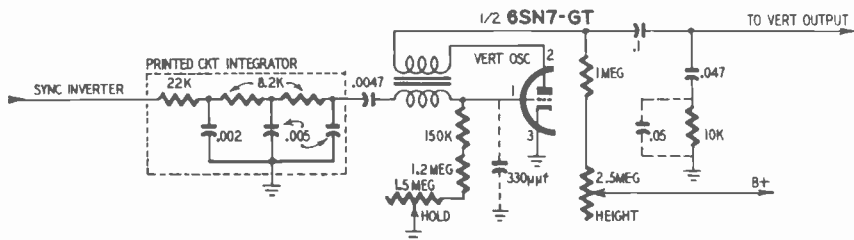
Fig. 1-I. Three-section sync integrator and its location with reference to the vertical oscillator.

oscillator tubes. A typical network consists of three resistors, 22K, 8.2K, and 8.2K in series; parallel capacitors .002  $\mu$ f, .005  $\mu$ f, and .005  $\mu$ f at junctions of these resistors; all capacitors connected to ground. See Fig. 1-I for typical circuit .

A defect in the integrator network can cause poor interlace,

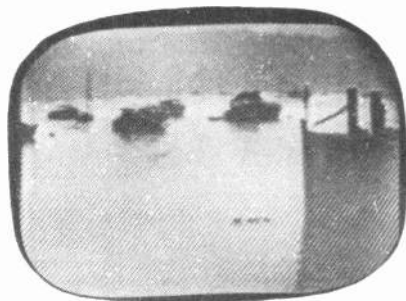
Fig. 3-I. *Strong interference produces diagonal lines on screen.*

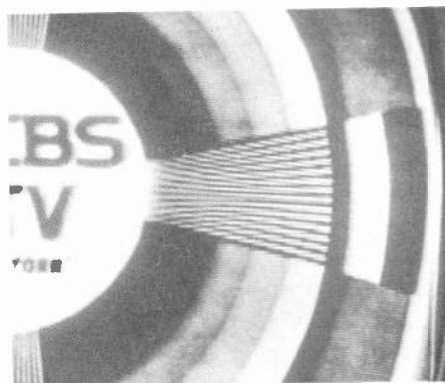
Fig. 4-I. *Poor interlace as indicated by moire effect on horizontal wedge.*

**SYMPTOMS:** Poor interlace indicated on screen by moire effect of horizontal wedge in test pattern. White horizontal sweep lines not equally spaced but close together, or both light and dark. Pairing of lines with black space between is especially noticeable on large screens. Horizontal lines look coarse. See Fig. 4-I.

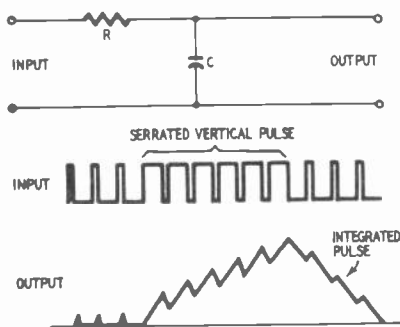
Fig. 5-I. Integrator circuit showing input and output waveforms.

**SERVICE:** To get best interlacing, adjust brightness control until retrace lines can be seen. Turn vertical-hold control until the retrace lines are equally spaced. This usually happens with the vertical-hold control set close to the point where the pix breaks out of vertical sync and starts rolling upward. If this adjustment of the vertical-hold control does not eliminate pairing of retrace lines (that is, if all the retrace lines cannot be spaced evenly) then there may be trouble in the integrator network (input to the vertical oscillator). Defective capacitors in the integrating network are the most common cause. The action of a simple integrating network is shown in Fig. 5-I.

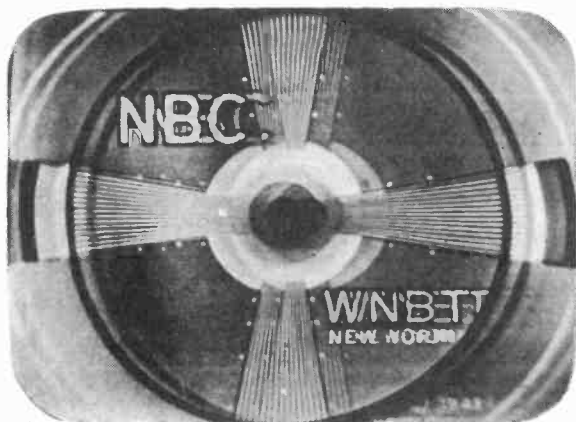
Fig. 1-J. *Example of horizontal jitter.*

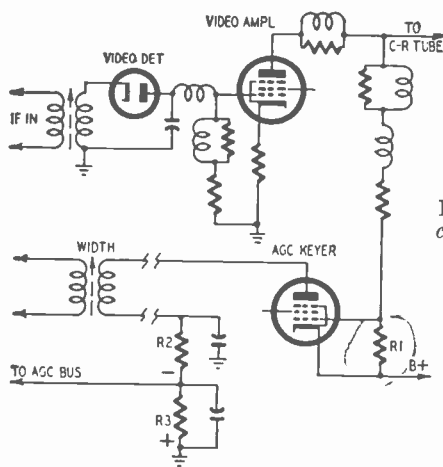
Fig. 1-K. Agc keyer circuit. Width coil is part of horizontal-output transformer.

caused by a low-emission video amplifier resulting in too small a voltage drop across the keyer input resistor R1 in Fig. 1-K. This resistor is a critical factor in proper agc action. If it varies in value, it will cause considerable changes in bias voltage. Equally critical is the plate current flow through this resistor. Both should be checked carefully.

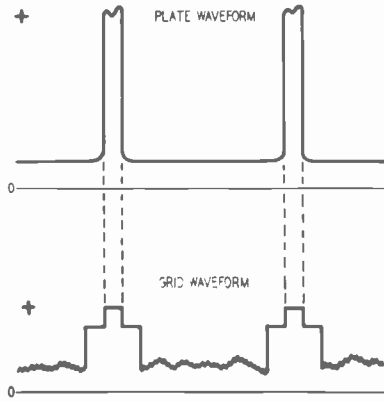
Fig. 2-K. Keyed agc grid and plate waveforms.

It might seem that one of the essentials of proper keyed agc action, that of simultaneous positive grid and plate voltages, would be automatic. Refer to Fig. 2-K. Yet, if the horizontal oscillator is out of sync, the horizontal plate pulse will not occur at the right time, and proper agc voltage will not be developed. The same trouble can occur with a poorly operating afc circuit, since this circuit has considerable control over the horizontal oscillator.

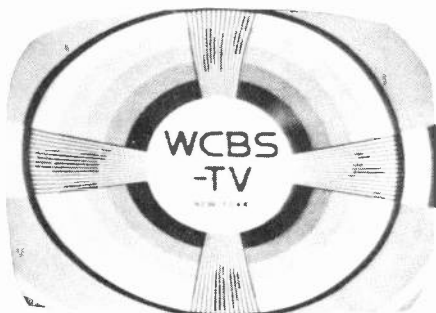
Fig. 1-L. *Test pattern shows left-hand stretch.*

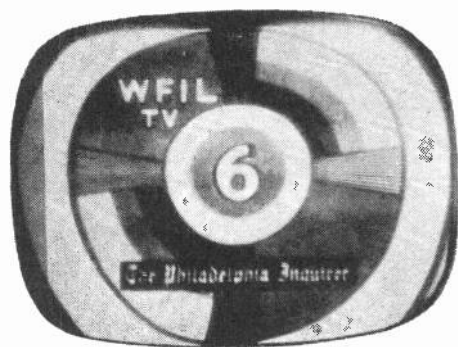
Fig. 2-L. *Effect on pix of line-voltage change.*

**SYMPTOMS:** Picture size and contrast change when electrical appliances are turned on. See Fig. 2-L.

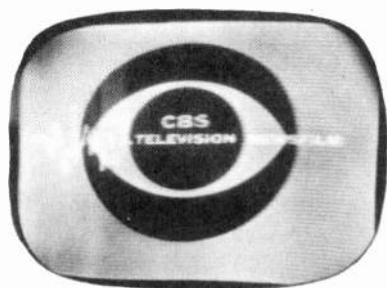
Fig. 3-L. *Low-voltage B+ causes reduction in height and width.*

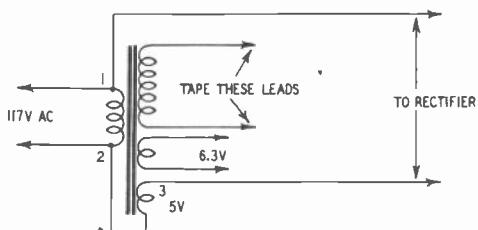
Fig. 5-L. Spare power transformer can be used to give line voltage boost.

Connect the ac power line to the 117-volt primary winding as shown in Fig. 5-L. Now make a temporary connection of the filament winding and measure the voltage across 1 and 3. If it is less than the voltage across 1 and 2, reverse the filament connections.

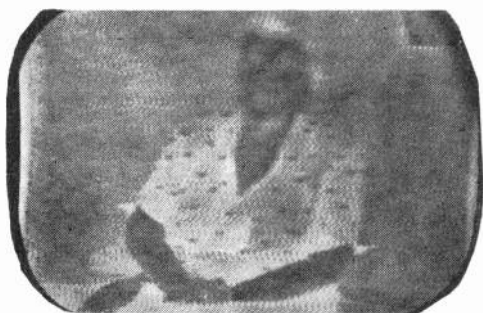
*Fig. 1-N. Negative pix can be caused by overloading, defective pix tube, outside interference, or circuit defects.*

Fig. 1-N, for example, shows a negative pix, but does this type of pix occur only for the strongest station? If so, it would indicate temporary overloading. Does the pix turn negative only occasionally? If so, it might indicate strong local interference from a shortwave station. Is the pix always negative, even though the antenna lead-in is disconnected and receiver circuits check all right? The pix tube is probably defective. The agc can cause a negative pix on weak stations too. It all depends on the setting of the agc control. Obviously, a correct diagnosis of the trouble can be made only if all symptoms are considered.

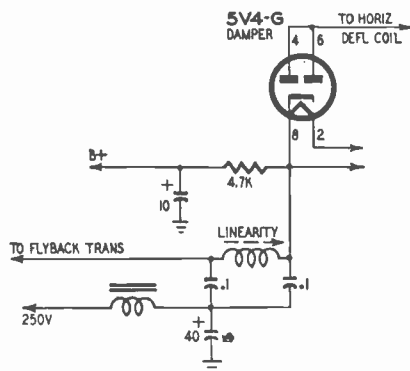
Fig. 2-N. Damper tube and horizontal-linearity circuit.

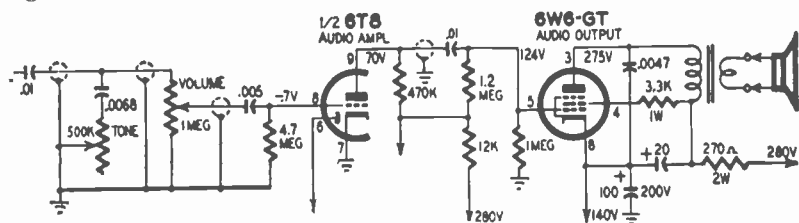
Fig. 3-N. Typical audio amplifier and output circuits.

**SERVICE:** Check by substitution, all tubes beginning with the sound take off point, including audio if amplifiers, audio detector and output tubes (Fig. 3-N). Tune in pix. Adjust volume control near maximum position. If no sound, check speaker cable. If hum or buzz are present, speaker and cable are satisfactory. If this condition is noted on only one or several channels, the individual oscillator slugs in the tuner may require adjustment.

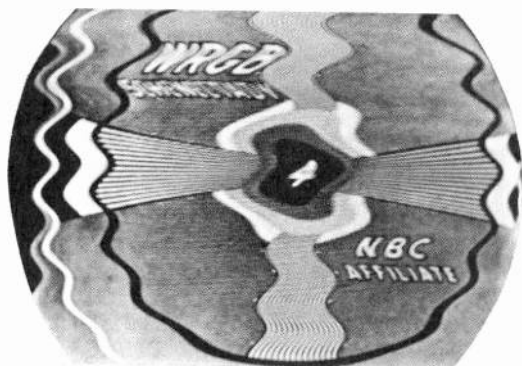
Fig. 1-P. *Pie-crust effect in pix.*

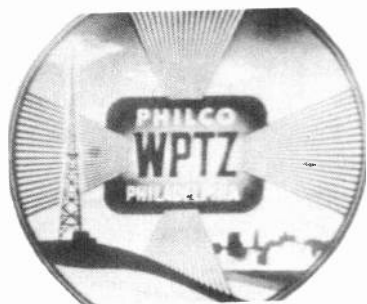
Fig. 2-P. *Pincushion effect in pix.*

Unless a station pattern is on, or a cross-bar generator used, the pincushion effect may not be too noticeable. But when viewing televised scenes with vertical or horizontal sections, the viewer would notice the bending effect and distortion. Adjustments are simplified if the picture size is reduced slightly so the pincushion effect can easily be seen. The magnets should then be adjusted until the picture is perfectly rectangular, after which the size can be increased to fill the mask properly.

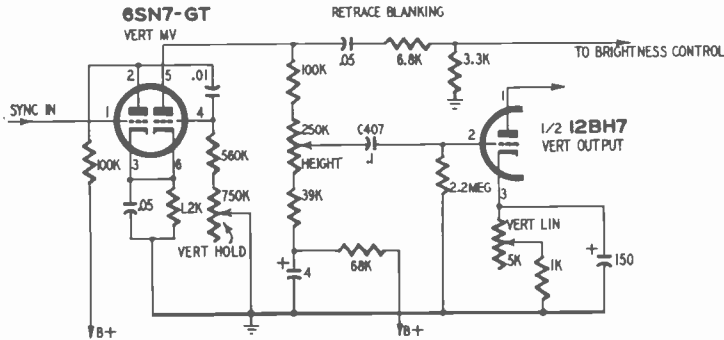
Fig. 3-P. Defective components in vertical oscillator and output can cause pix compression at top.

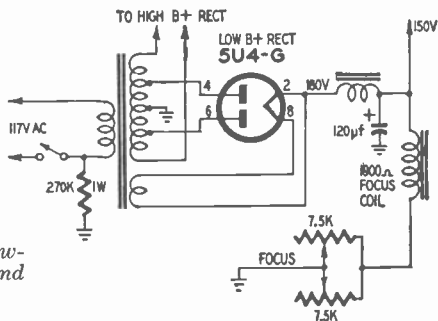
Fig. 4-P. Focus coil is part of low-voltage supply. See also Fig. 2-F and Fig. 3-F.

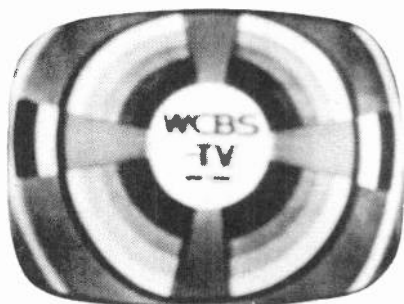
*Fig. 5-P. Defect in video amplifier can produce poor-quality pix.*

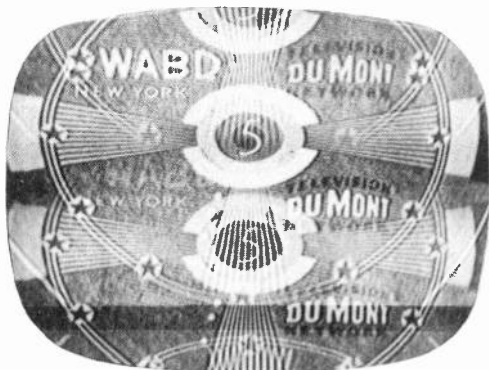
Fig. 6-P. Defect caused by trouble in vertical-hold control circuit.

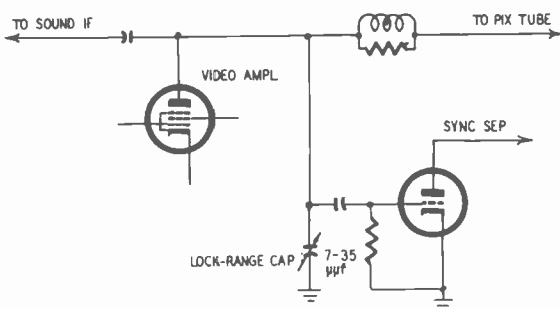
Fig. 7-P. Lock-range capacitor in sync separator circuit.

**SERVICE:** On local stations the picture is so strong that it overloads the video amplifier. This causes the sync pulses to be clipped, which in turn makes the horizontal sweep unstable. Use a smaller

coupling capacitor from sync to afc, or use a lock-range capacitor.

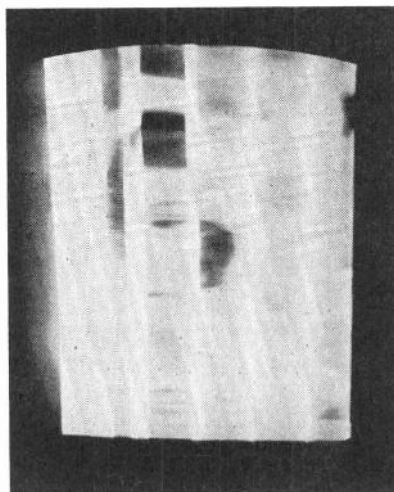
Fig. 8-P. *Pix pullout caused by open coupling capacitor.*

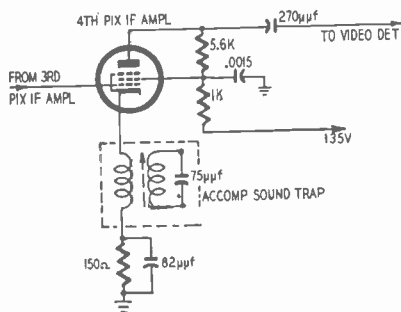
Fig. 9-P. Overloading of last pix if amplifier produces loss of horizontal and vertical sync.

**SERVICE:** Pix tearing and rolling on strong signals may be caused by overloading of the 3rd video if amplifier. The low plate voltage of this tube and higher signal input (compared to preceding stages) can prevent it from properly handling strong signals. (Check bias on this tube.) See Fig. 9-P.

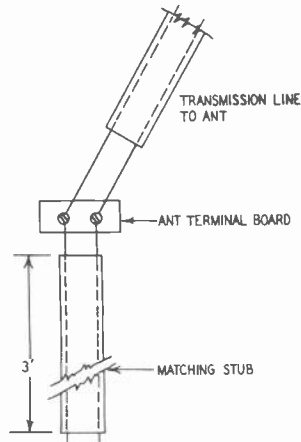
Fig. 10-P. *Matching stub can be made from scrap piece of transmission line.*

Connect about three feet of line to antenna terminals. See Fig. 10-P. This piece is a matching stub. Starting at end closest to antenna terminals, short the transmission line with a sharp razor blade. Set should be tuned to channel giving worst smear. At point where shorting the line with the blade produces the best pix, cut across with diagonal cutters and join the ends together. The regular antenna line should remain connected in the usual way and not be disturbed during this repair. Stub can be allowed to hang

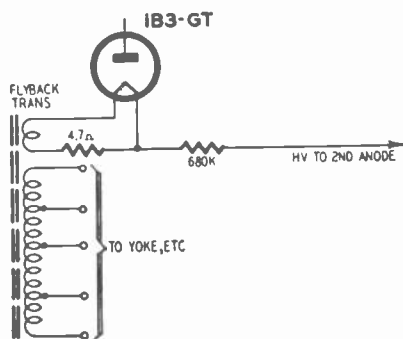
Fig. 1-R. HV rectifier circuit.

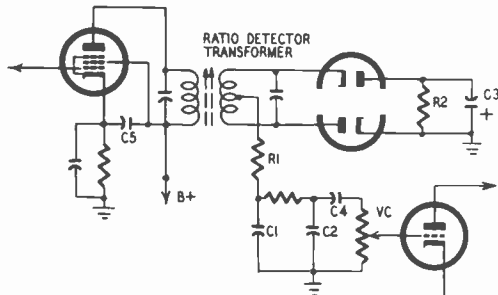
Fig. 2-R. Ratio-detector circuit. See ratio-detector check list.

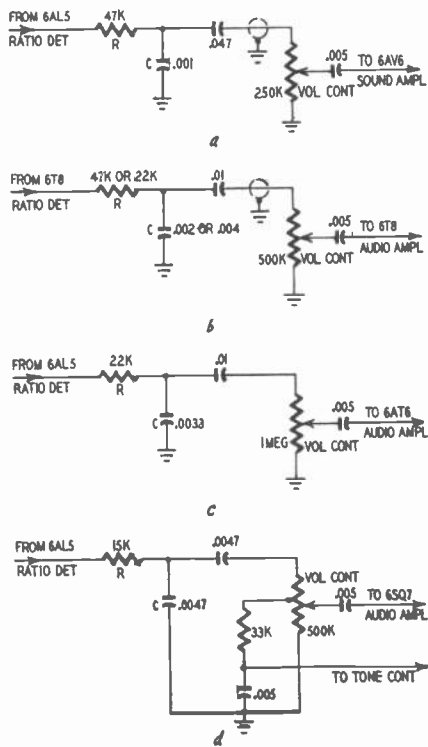
Fig. 3-R. Typical de-emphasis networks.

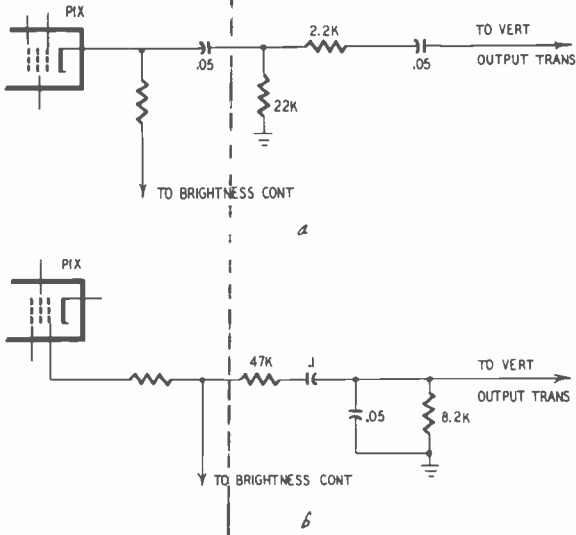
Fig. 4-R. Vertical-retrace blanking networks.

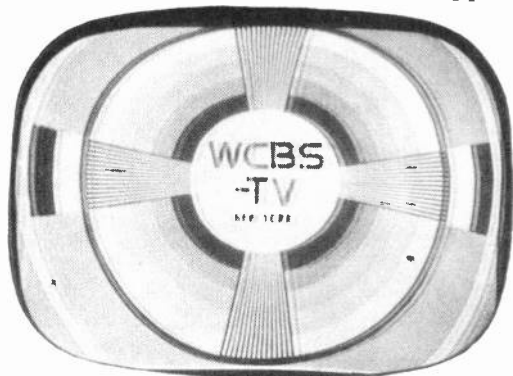
Fig. 5-R. *Pix of test pattern shows echo.*

Echo or ringing usually occurs for *every* station tuned in. Contrast this to ghost reception which will usually show up for only one or two stations, and has more pronounced picture displacement. Echo effect (see Fig. 5-R) is caused by an overpeaked video amplifier or by a misaligned video if section. High-frequency components of the signal pulse the offending stage into transient oscillation which causes the repeat lines to appear as sharply

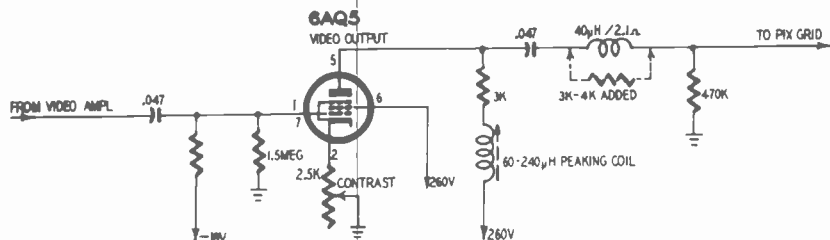
Fig. 6-R. Resistor across peaking coil helps eliminate ringing.

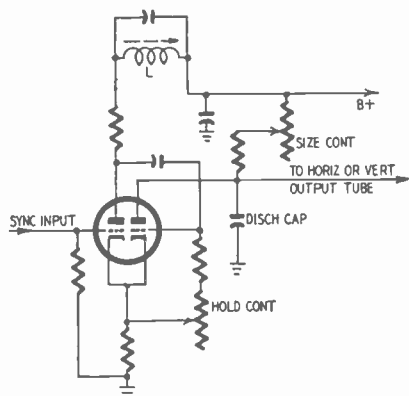
Fig. 7-R. Horizontal multivibrator may have ringing coil, *L*.

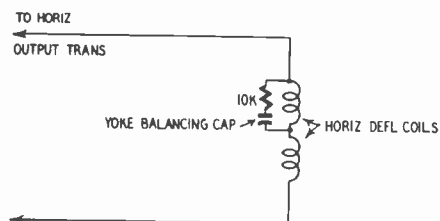
Fig. 8-R. R-C network across horizontal-deflection coil reduces ringing.

The correct value of this capacitor is important (2,000 volt rating). In some instances addition of a 10K ohm resistor in series with the yoke balancing capacitor may overcome this trouble, though width may be reduced. See Fig. 8-R. For high-impedance yokes try connecting a .047  $\mu$ f, 400-volt capacitor across the vertical section of the yoke. Another cure might be connecting a 5,600-ohm resistor across the horizontal-linearity coil.

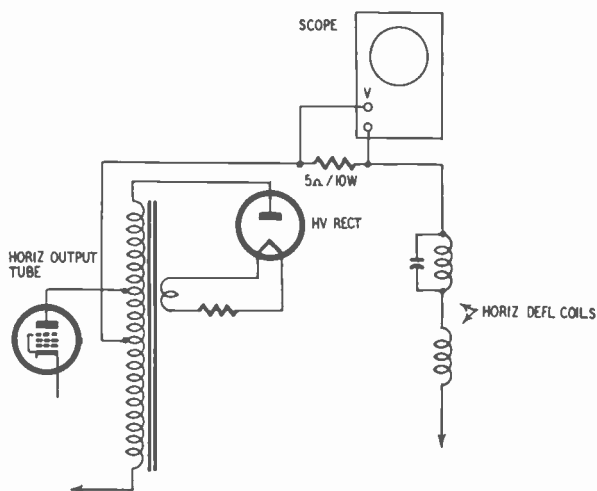
Fig. 10-R. Method of checking horizontal-sweep waveform.

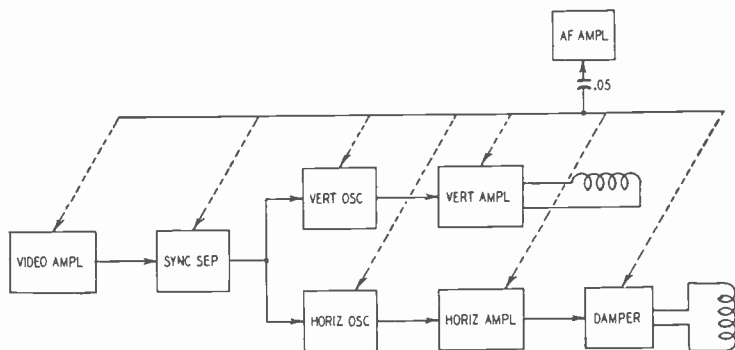
Fig. 1-S. Audio section of TV receiver can be used in testing.

Headphones are splendid for audio work. High-impedance units connected in series with a .05- $\mu$ f capacitor are ideal for tracing a signal from the sound-detector output to the speaker voice coil. Thus, when there is no audio output or there is distortion resulting from a defect within the audio section of a receiver, the technician can start at the output of the detector and work toward the speaker, picking up a clear signal and tracing it to a point where it disappears or becomes distorted. This pretty much pinpoints the source of the trouble.

From here it becomes a simple matter of signal tracing. You can start either at the plate of the audio-output tube and work toward the detector while listening for the signal at the speaker, or inject the signal at the detector output and trace toward the speaker, using headphones. In either case, the signal will consist of the all-too-familiar 60-cycle hum.

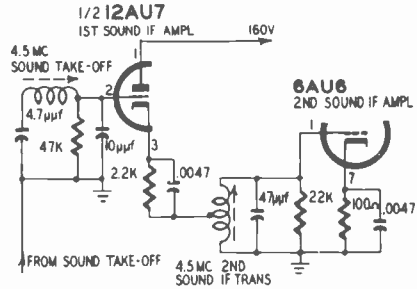
Fig. 2-S. Typical sound if stages.

**SERVICE:** Sound if and FM detector alignment are the first consideration. Any unbalance in the detector (including a faulty tube) may be the trouble. Do not overlook the usual causes of distorted sound following the FM detector in the audio portion. Distortion can be caused by loose slugs in sound if and detector transformers. Many cases of distorted or missing sound are due to improper operation of the receiver's controls but some may be traced to excessive oscillator drift. A bad tube is usually at fault when poor front-end design is not evident. Misalignment of the rf and if stages is an obvious cause of the same trouble. (A common mistake is to realign the picture if rather than the sound stages. The sound if bandpass is not as wide as that of the video if; therefore the former is more critical.) Fig. 2-S shows circuits of typical sound if stages.

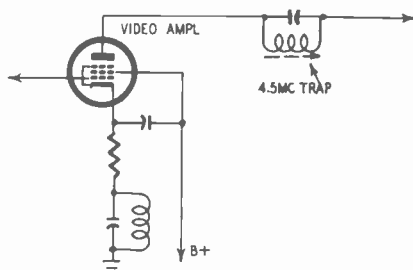
Fig. 3-S. Misaligned sound trap results in sound bars in pix.

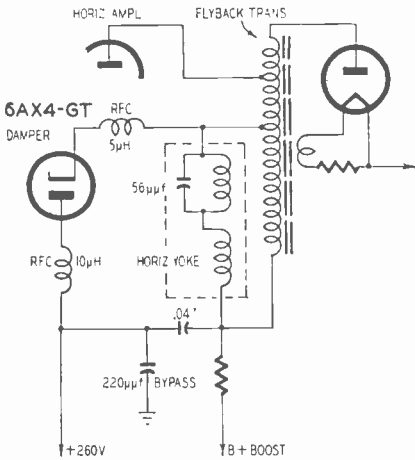
Fig. 4-S. Spooks can be eliminated by rf chokes in the damper-tube circuit.

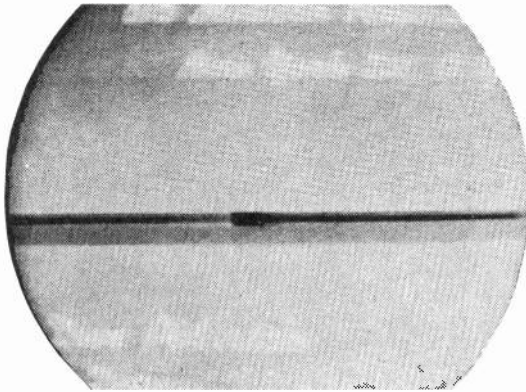
*Fig. 5-S. Blanking bar showing sync pulse.*

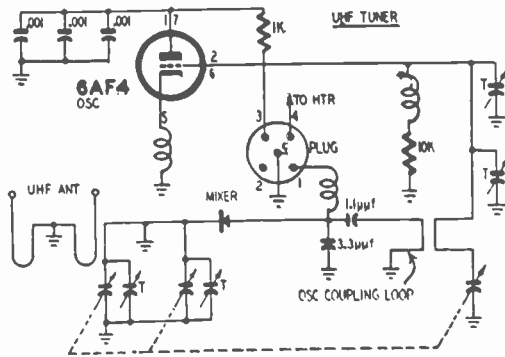
Fig. 2-T. Simplified circuit of uhf tuner.

In uhf tuners (see Fig. 2-T) if trouble occurs in oscillator, the pix usually disappears; when there is a defect in rf and mixer stages, a decrease in signal will result. To adjust individual oscillator channel slugs always set fine-tuning control at center of range.

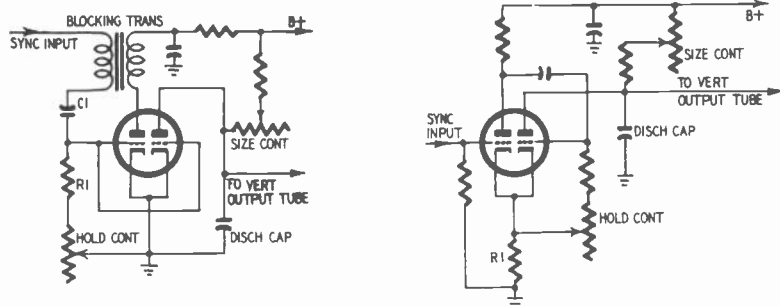
Fig. 1-V. Vertical-blocking oscillator and multivibrator circuits.

Vertical-deflection stage may be checked by connecting each stage to the top of the volume control through a .1  $\mu\text{f}$  capacitor.

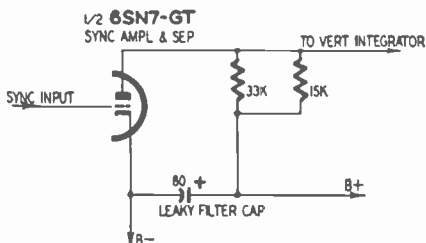
Fig. 2-V. Leaky filter capacitor can produce vertical jitter.

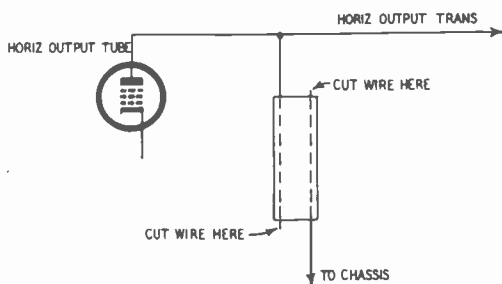
*Fig. 3-V. Capacitor made from a small piece of transmission line. Use the minimum amount of transmission line needed to increase pix width. One side of the line can connect directly to the plate cap of the horizontal-output tube. Fasten the other side of the line to the chassis.*

circuit resulting from the rapid rise in deflection current. If the condition is very annoying, it may be possible to increase the width of the raster slightly to move the line beyond the mask. Adjust width control for maximum pix width. If this does not help, connect a high-voltage capacitor from the plate cap of the horizontal-output tube to chassis. You can easily make this capacitor from a small piece of transmission line as shown in Fig. 3-V. Use the smallest amount of line that will give the desired result. Keep the line clear of the chassis.

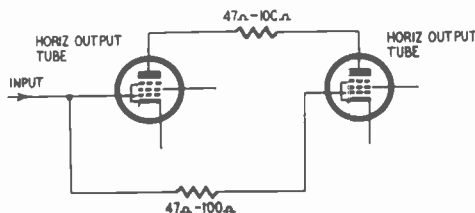
Fig. 6-V. Method of connecting parasitic-suppression resistors to horizontal-output tubes when the tubes are operated in parallel.

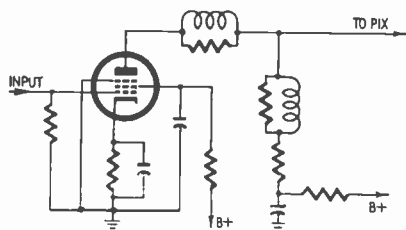
Fig. 7-V. The video amplifier is usually a single-tube circuit. This stage is often directly coupled to pix tube.

Most often is a single-tube circuit. In addition to amplifying the video signal, the video amplifier may be the sound take-off point in intercarrier sets, and also furnishes signals for noise-reducing and sync separator circuits. See Fig. 7-V.

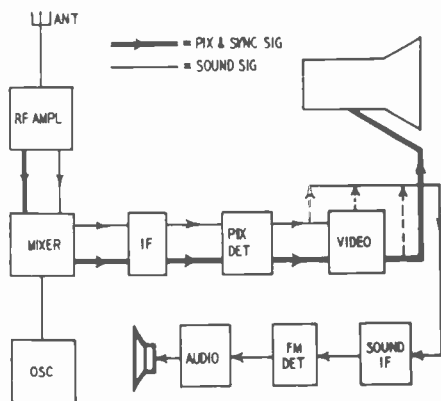
Fig. 8-V. Block diagram shows the paths of the pix, sync, and sound signals in an intercarrier receiver.

The video detector performs two functions: as an AM detector it rectifies and filters the modulated if input to deliver a composite video signal to the video amplifier. As a mixer it heterodynes the AM picture carrier with the FM sound carrier to produce the 4.5-mc intercarrier sound. Fig. 8-V shows the course of the signals.

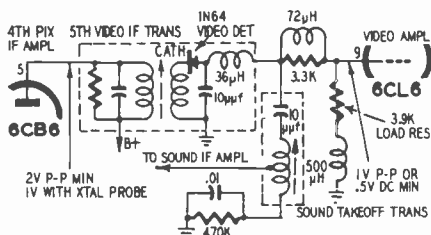
Fig. 10-V. Typical crystal-detector circuit. Crystal is enclosed in can with last if transformer.

The video detector may be a tube such as half a 6AL5. See Fig. 9-V. Typical modern crystal detector usage is shown in the schematic of Fig. 10-V; the crystal is in the last if can. The most
